**SECOND REVISED
DRAFT GENERIC ENVIRONMENTAL IMPACT STATEMENT**

FOR THE
WESTWOOD NEIGHBORHOOD
October 2015

Project Site located at
772 North Forest Road, and 385 and 391 Maple Road
Town of Amherst, Erie County, New York

Wetland Delineation Report

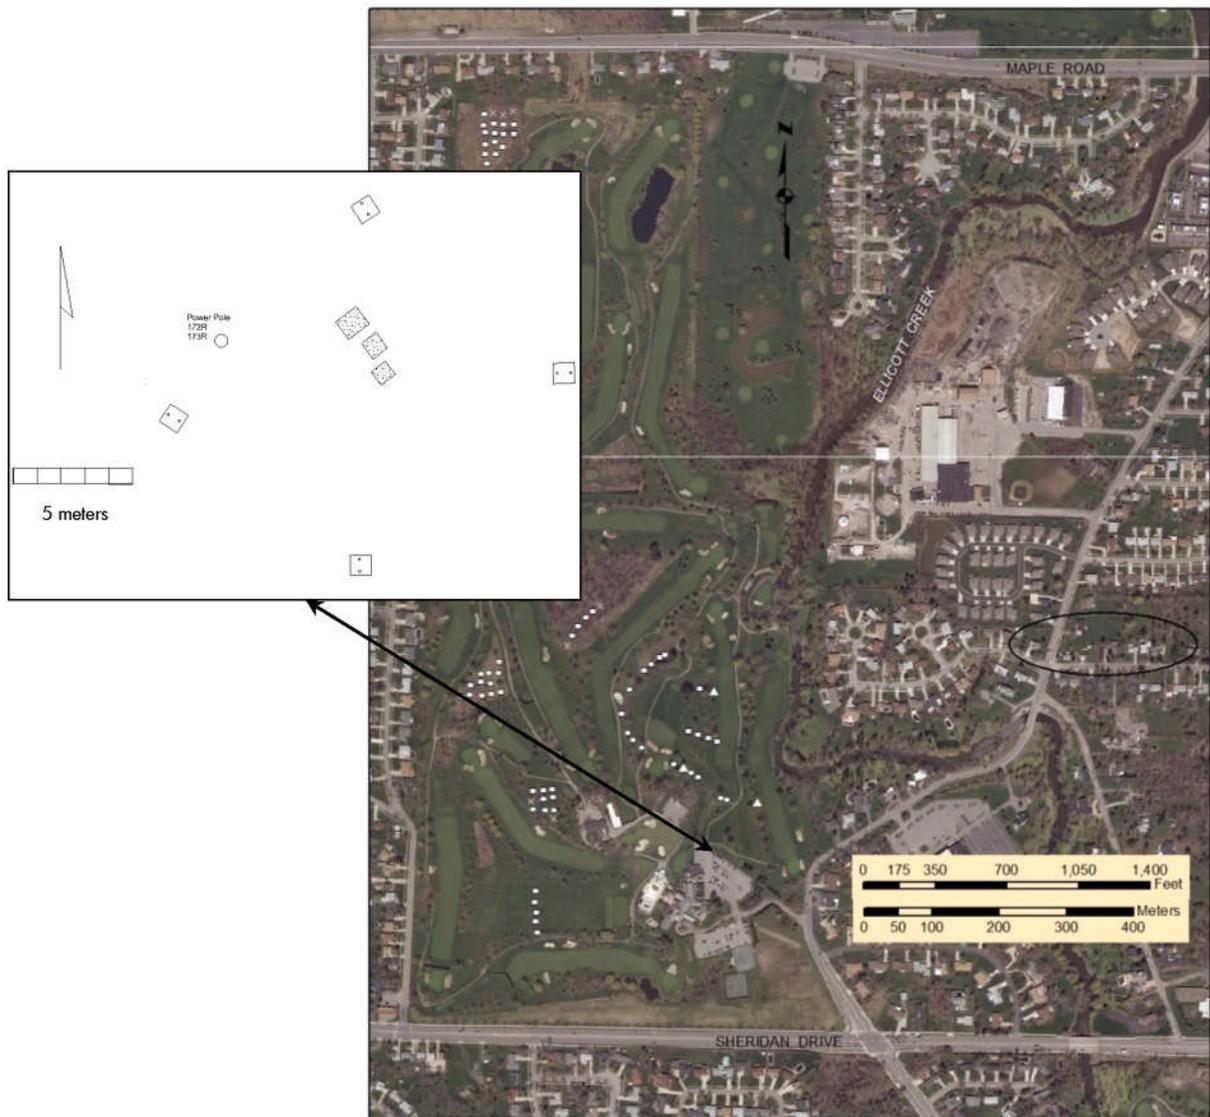
View of central slabs, structural feature. Test Area 6

Figure 10: Structural features located in Test Area 6.
